Report of the  
**PRESIDENTIAL  
COMMISSION**

*on the Space Shuttle  
Challenger Accident*

June 6th, 1986  
Washington, D.C.

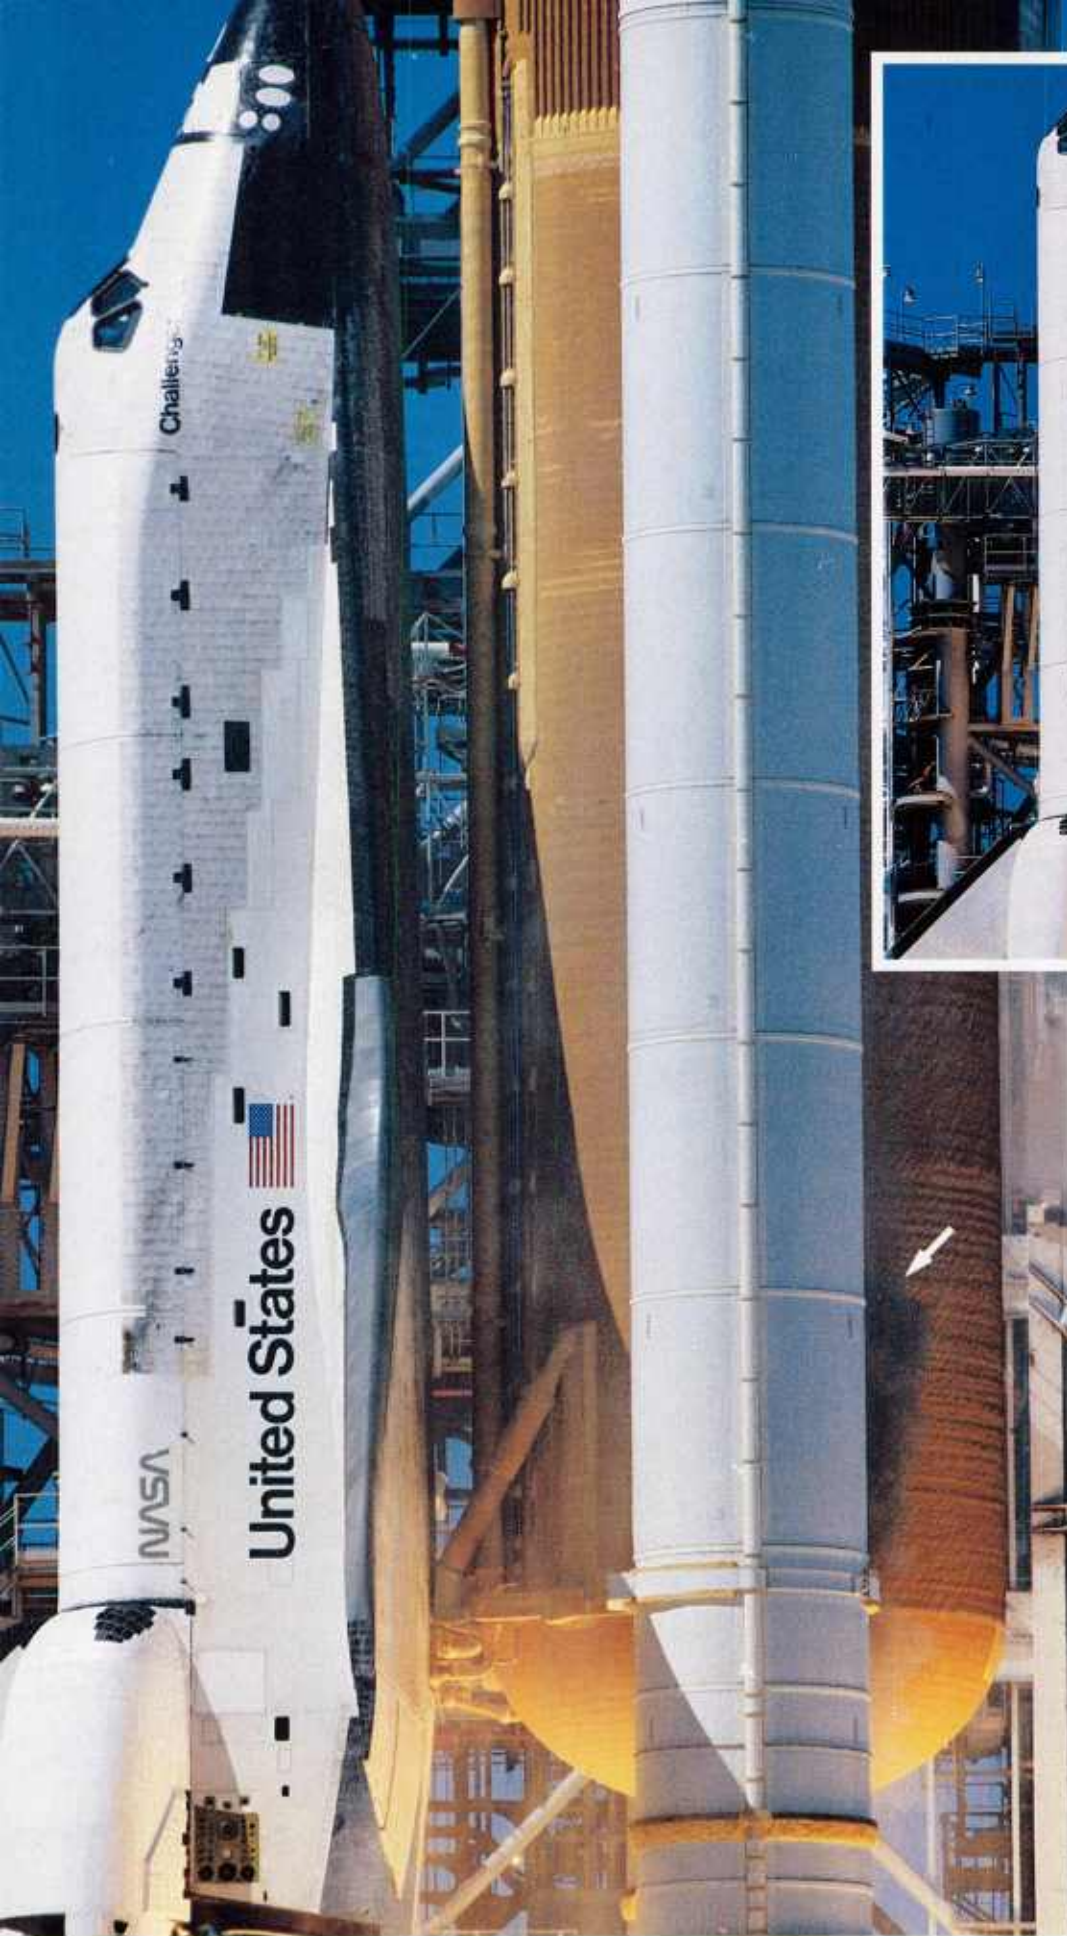
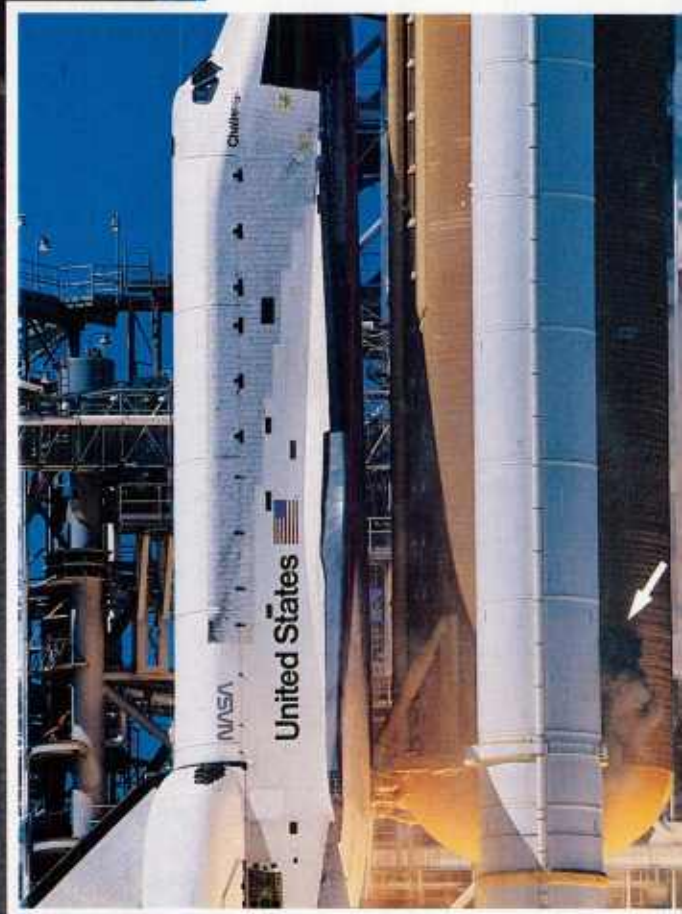
The black color and dense composition of the smoke puffs suggest that the grease, joint insulation and rubber O-rings in the joint seal were being burned and eroded by the hot propellant gases.

Immediately after solid rocket motor ignition, dark smoke (arrows) swirled out between the right hand booster and the External Tank. The smoke's origin, behavior and duration was approximated by visual analysis and computer enhancement of film from five camera locations. Consensus: smoke was first discernible at .678 seconds Mission Elapsed Time in the vicinity of the right booster's aft field joint.

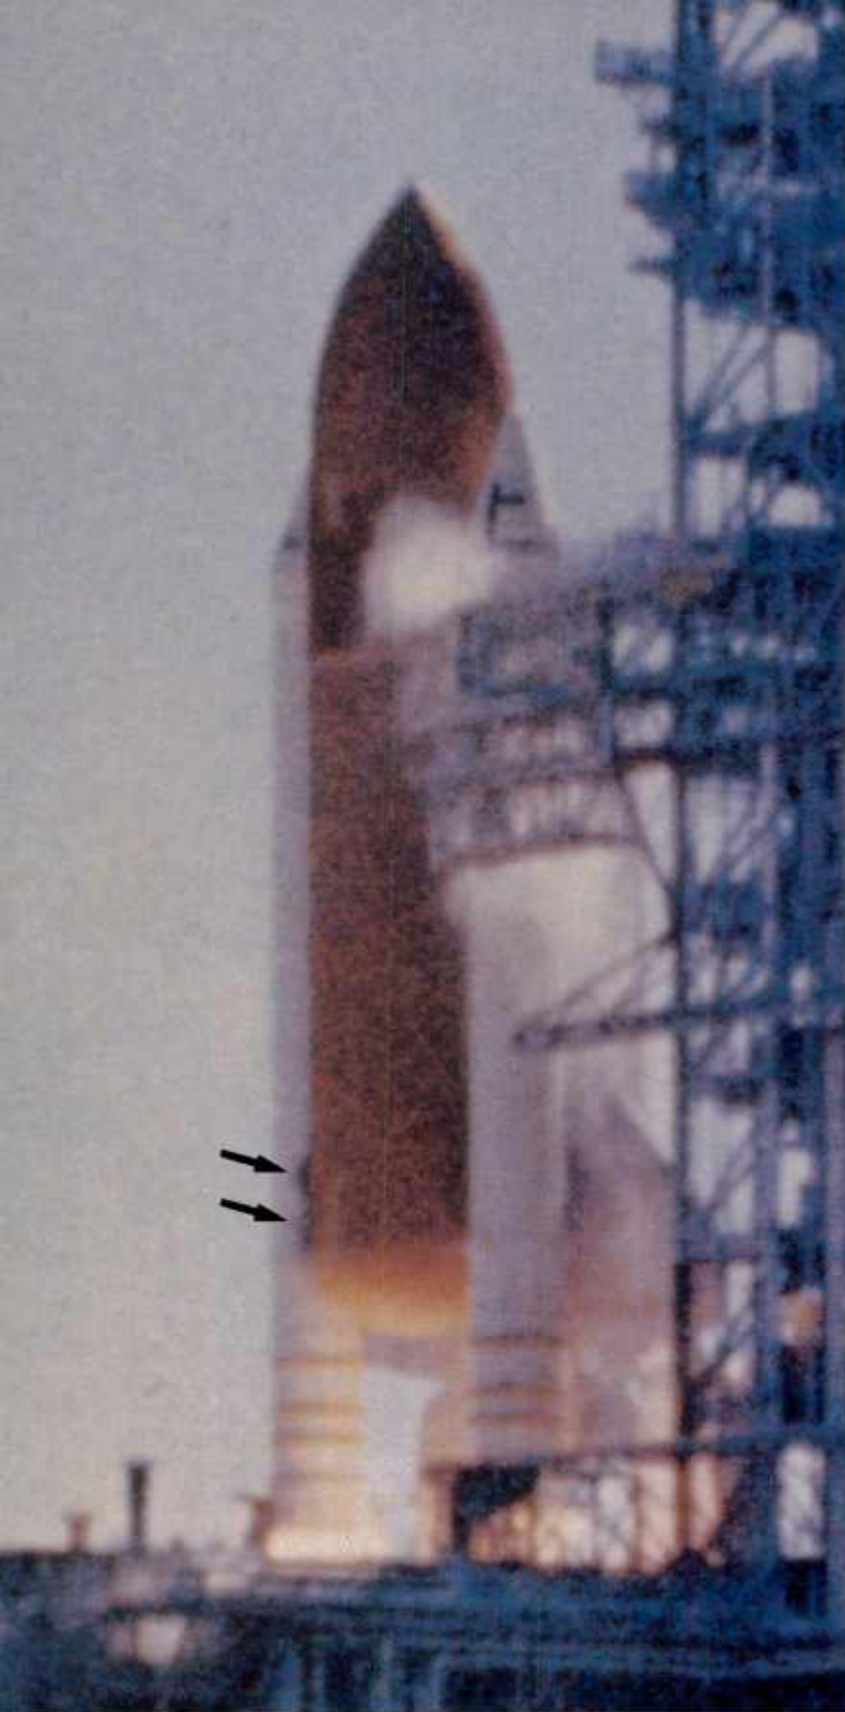
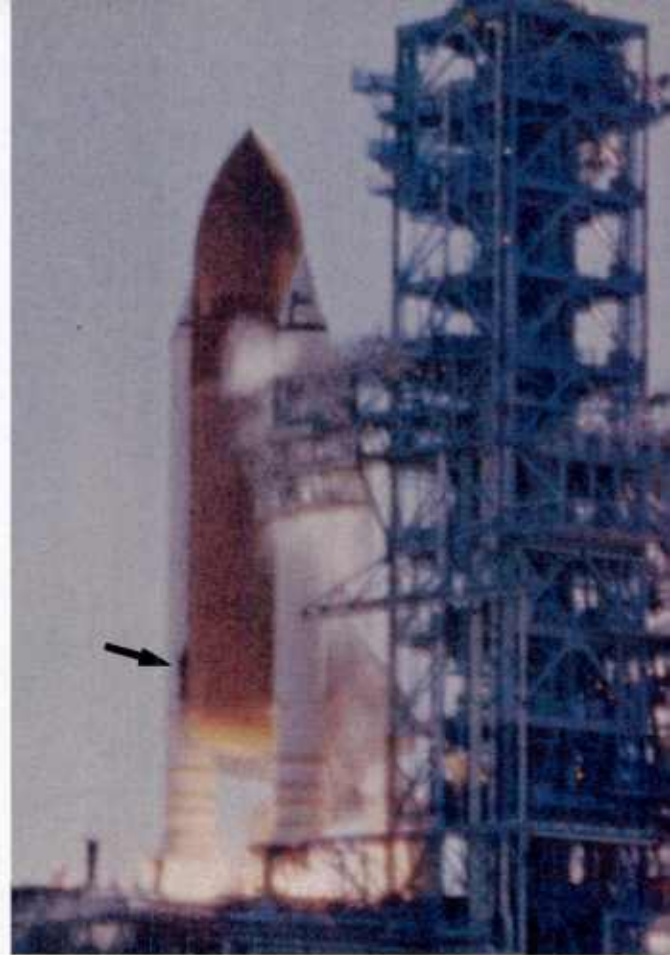
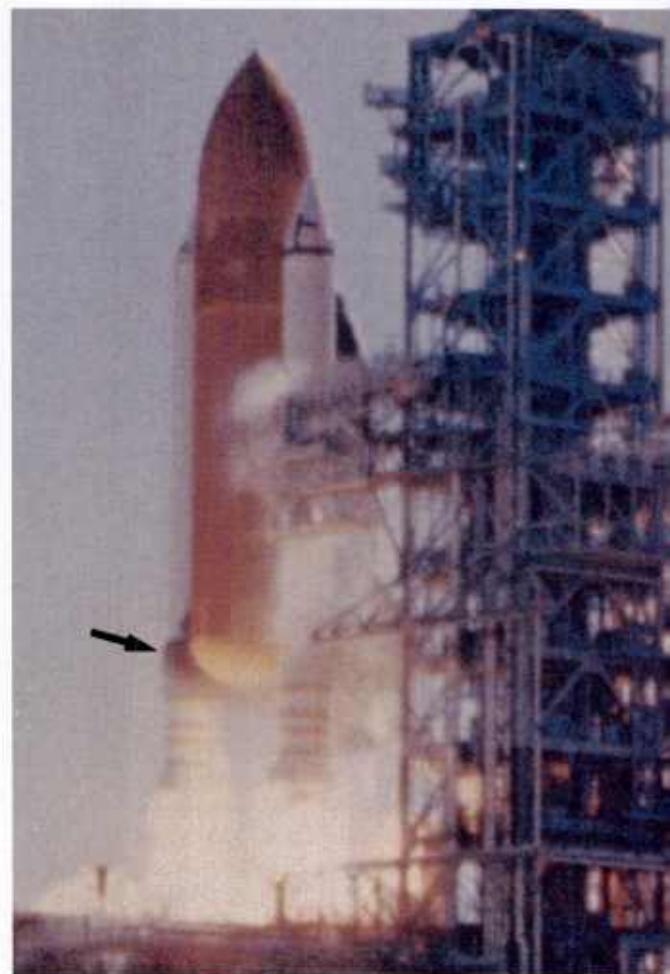
Multiple smoke puffs are visible in the photo above (arrows). They began at .836 seconds and continued through 2.500 seconds, occurring about 4 times a second. Upward motion of the vehicle caused the smoke to drift downward and blur into a single cloud. Smoke source is shown in the computer generated drawing (far right).

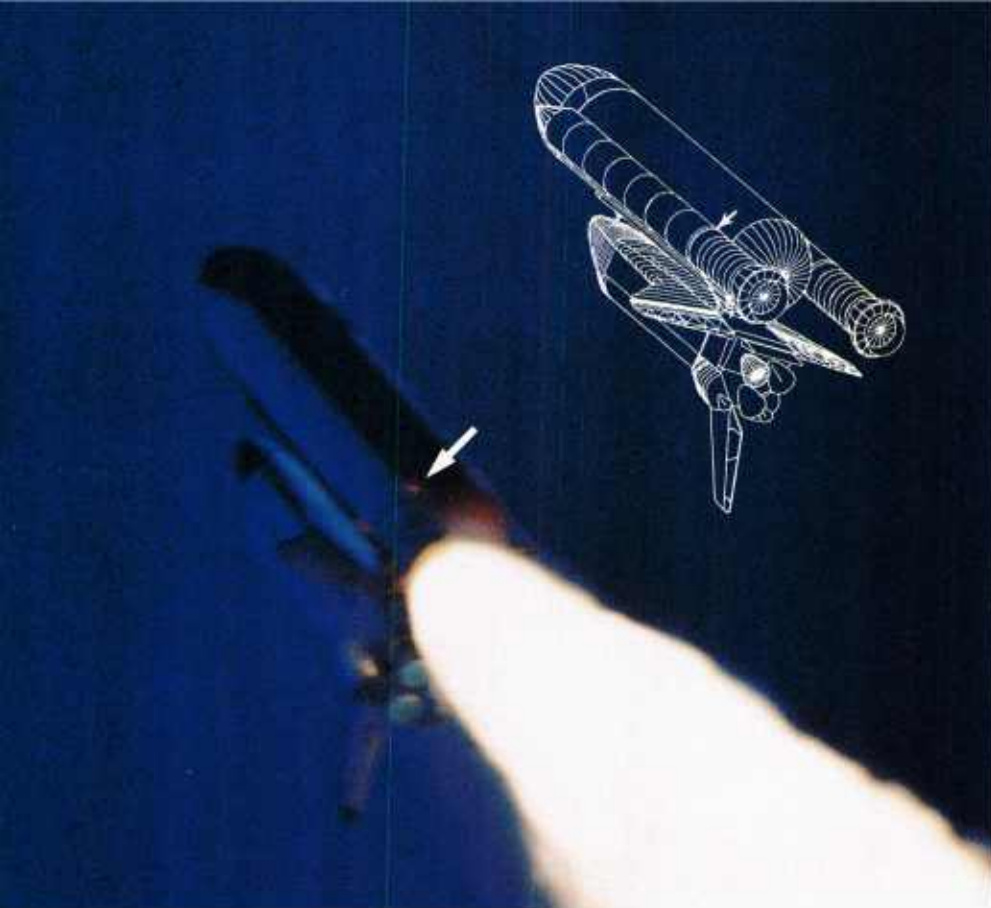
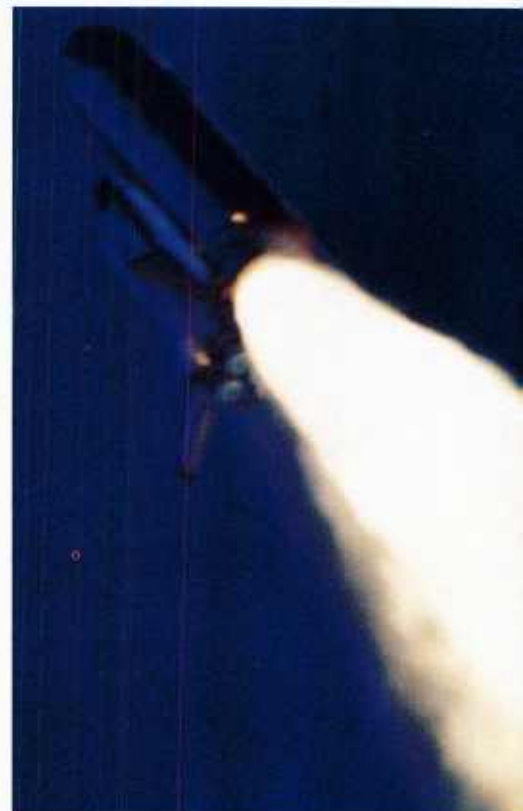
At 58.788 seconds, the first flicker of flame appeared. Barely visible above, it grew into a large plume and began to impinge on the External Tank at about 60 seconds. Flame is pinpointed in the computer drawing between the right booster and the tank, as in the case of earlier smoke puffs. At far right (arrow), vapor is seen escaping from the apparently breached External Tank.

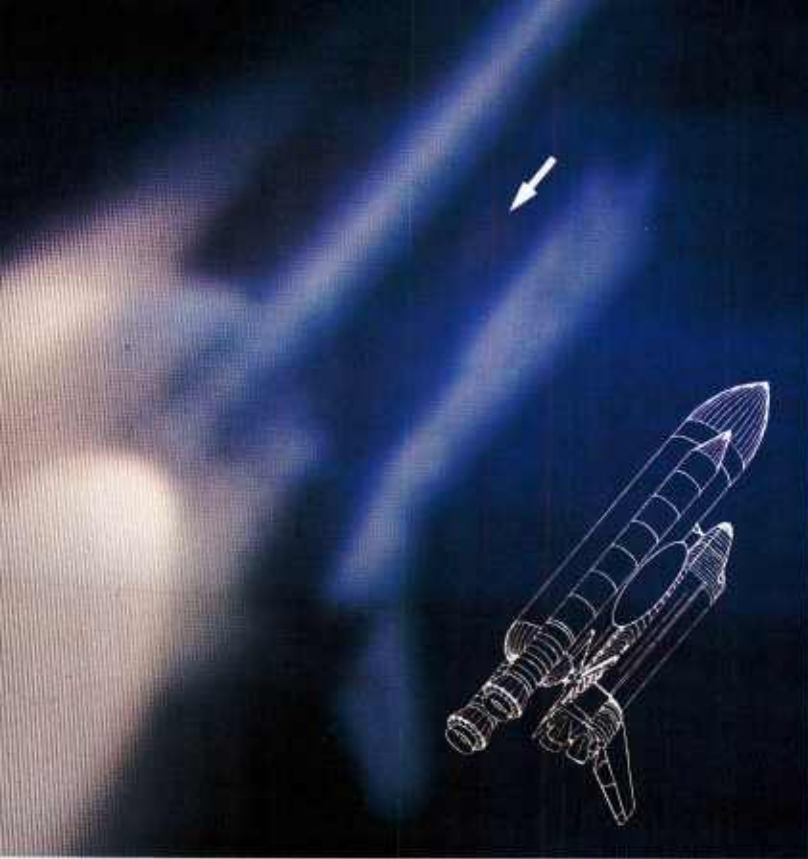
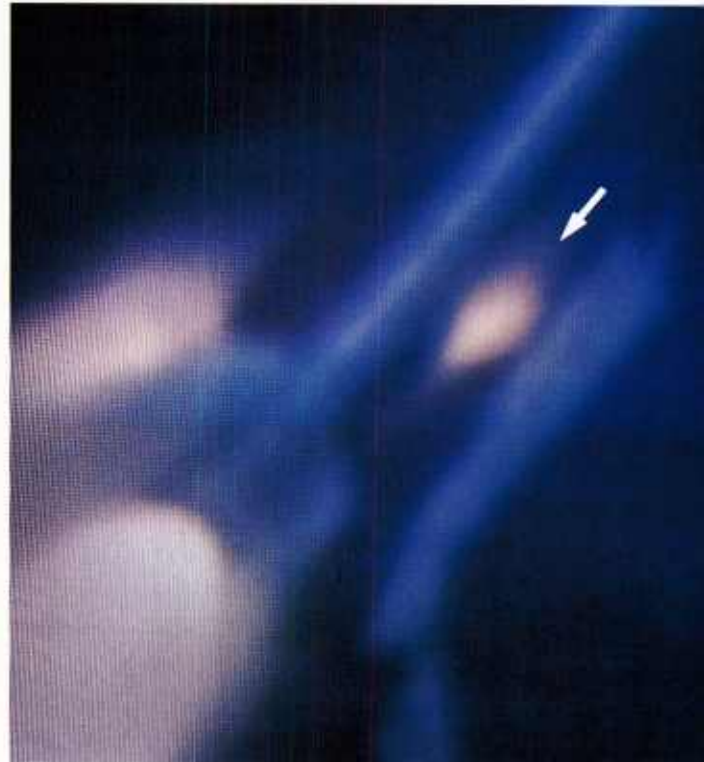
Camera views indicate the beginning of rupture of the liquid hydrogen and liquid oxygen tanks within the External Tank. A small flash (arrows above) intensified rapidly, then diminished. A second flash,

attributed to rupture of the liquid oxygen tank, occurred above the booster/tank forward attachment (below left) and grew in milliseconds to the maximum size indicated in the computer drawing.

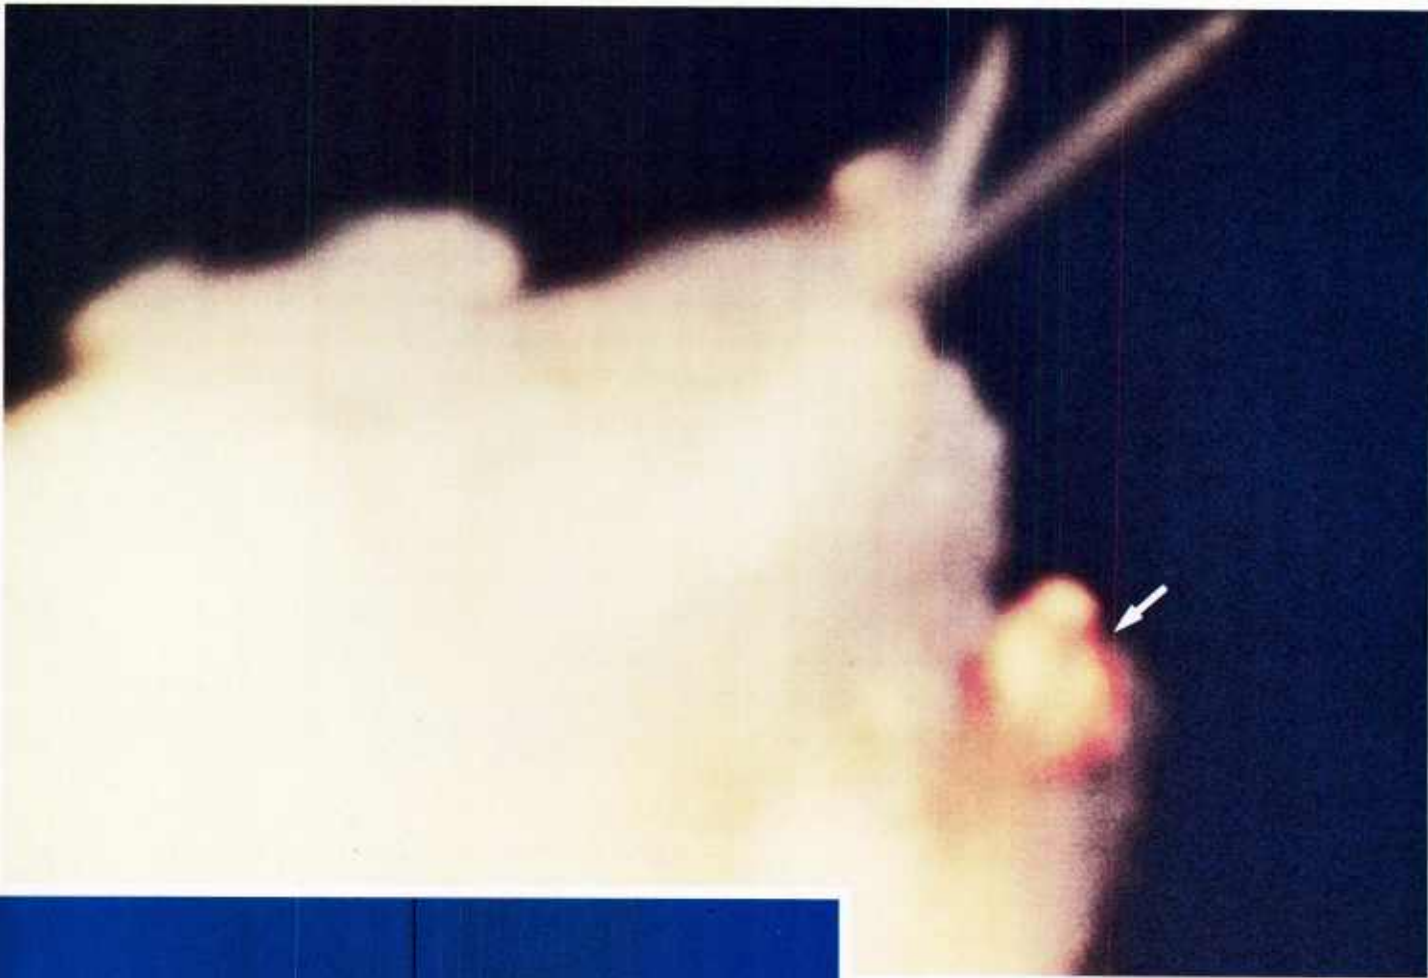
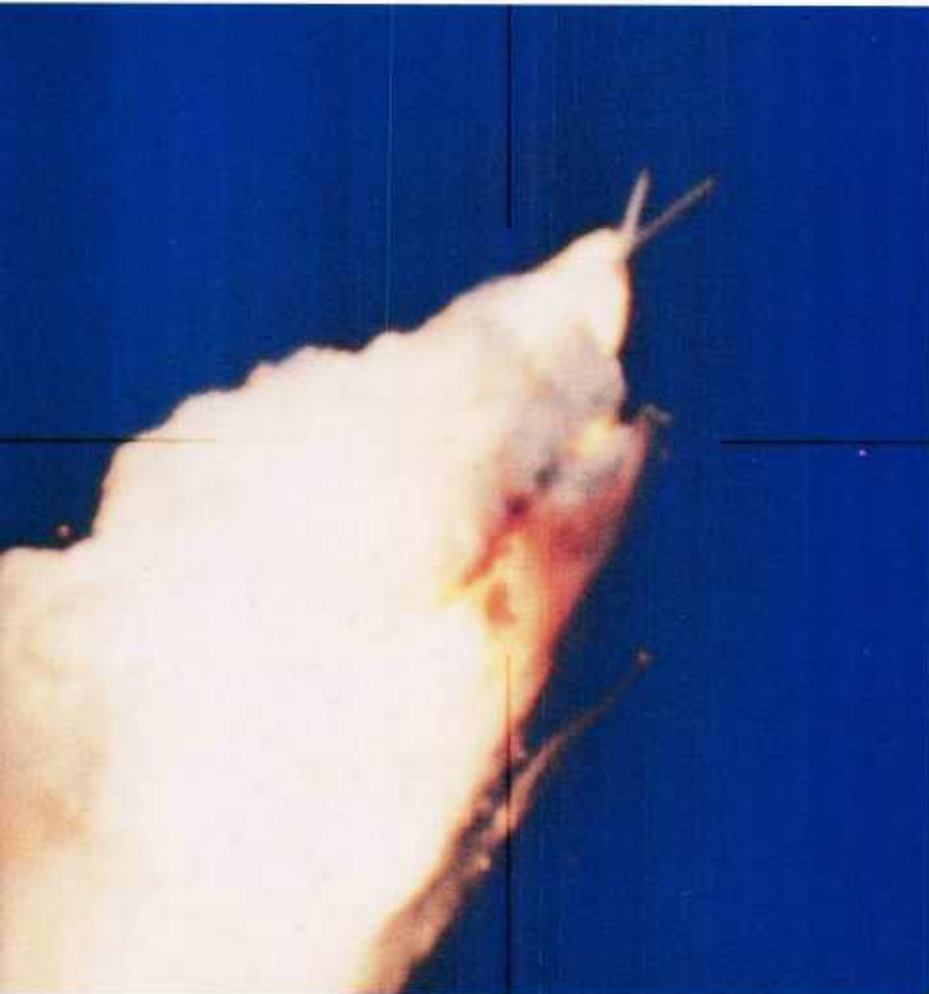
Structural breakup of the vehicle began at approximately 73 seconds. Fire spread very rapidly. Above, a bright flash (arrow) is evident near the nose of the Orbiter, suggesting spillage and ignition of the spacecraft's reaction control system propellants. At left, the two Solid Rocket Boosters thrust away from the fire, crisscrossing to form a "V." The right booster—identifiable by its failure plume—now to the left of its counterpart. At right, the boosters diverge farther; the External Tank wreckage is obscured by smoke and vapor. The Orbiter engines still firing, is visible at bottom center.

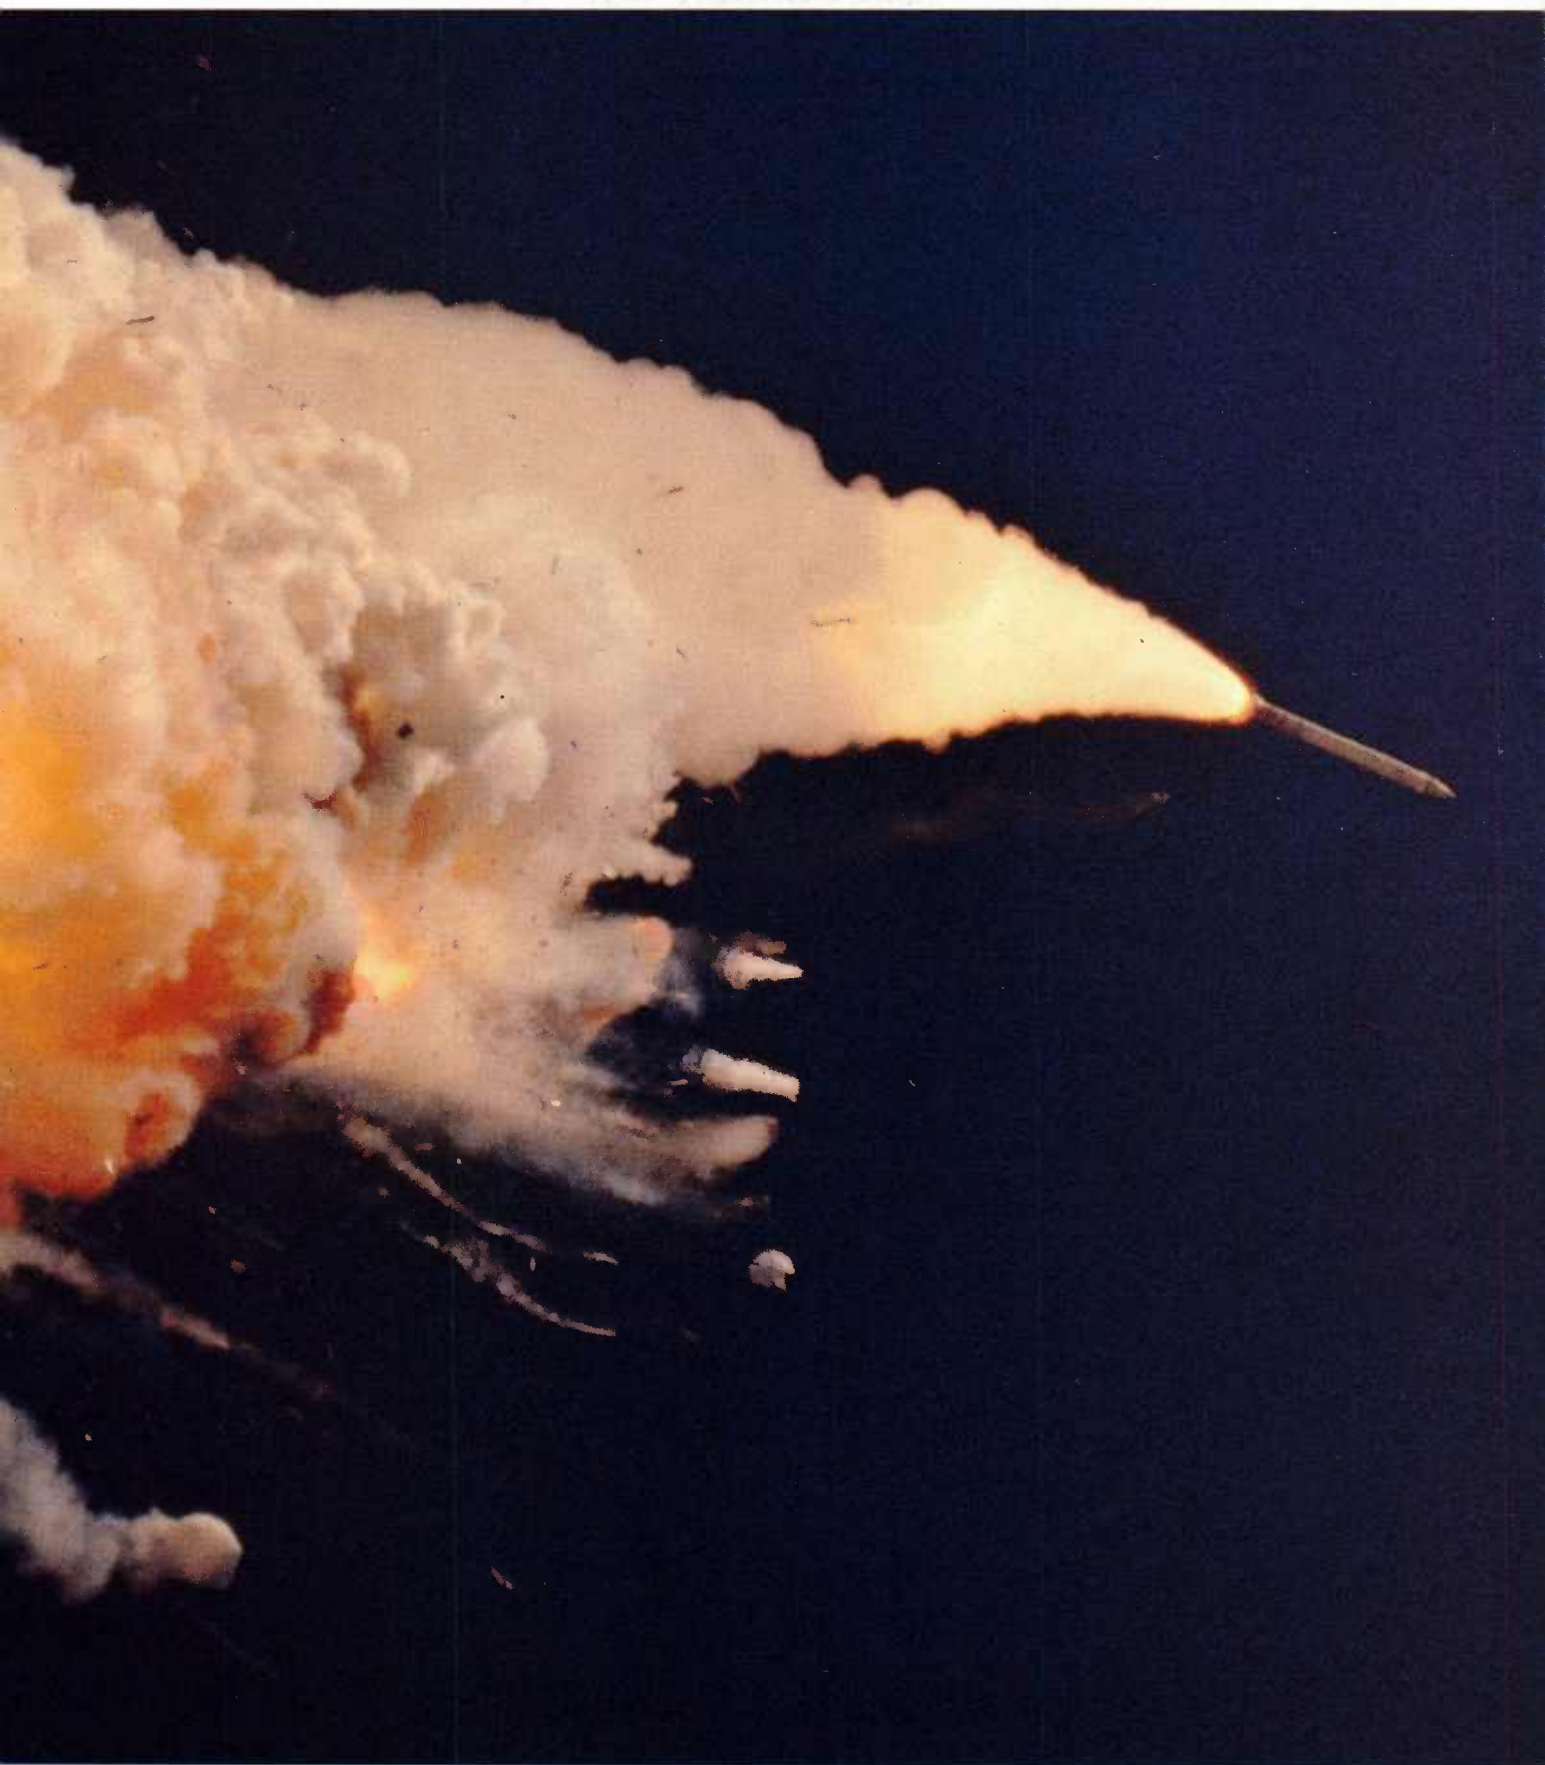
At about 76 seconds, unidentifiable fragments of the Shuttle vehicle can be seen tumbling against a background of fire, smoke and vaporized propellants from the External Tank (left). In the photo at right, the left booster (far right)

soars away, still thrusting. The reddish-brown cloud envelops the disintegrating Orbiter. The color is characteristic of the nitrogen tetroxide oxidizer in the Orbiter Reaction Control System propellant.

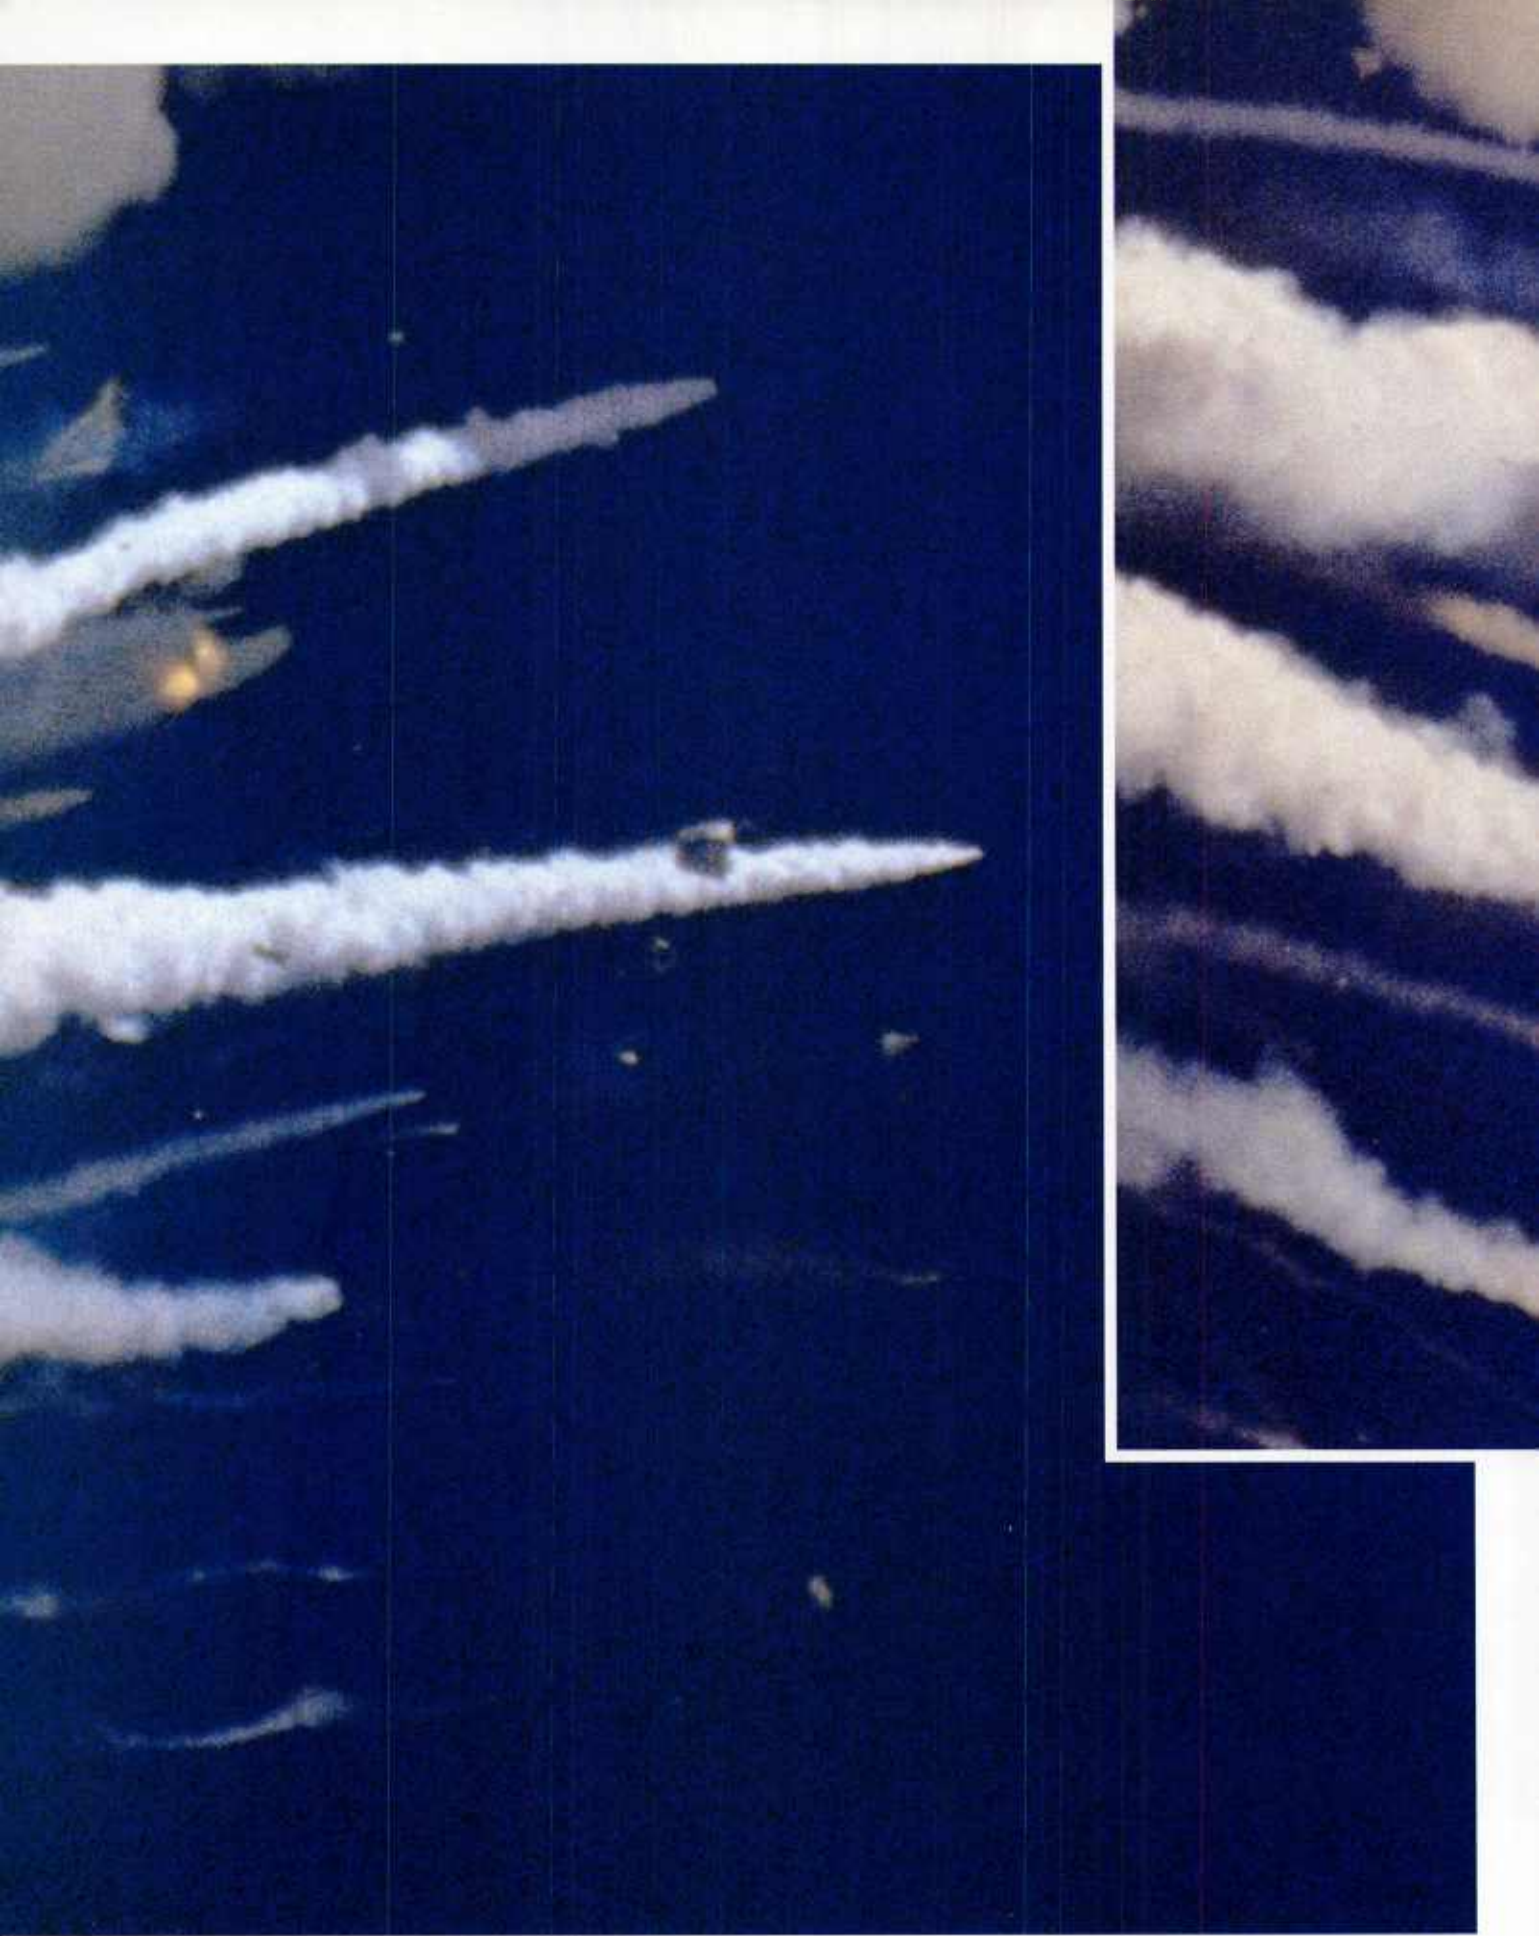
Hurling out of the fireball at 78 seconds (left) are the Orbiter's left wing (top arrow), the main engines (center arrow) and the forward fuselage (bottom arrow). In the photo below, it plunges Earthward, trailed by smoking fragments of Challenger.

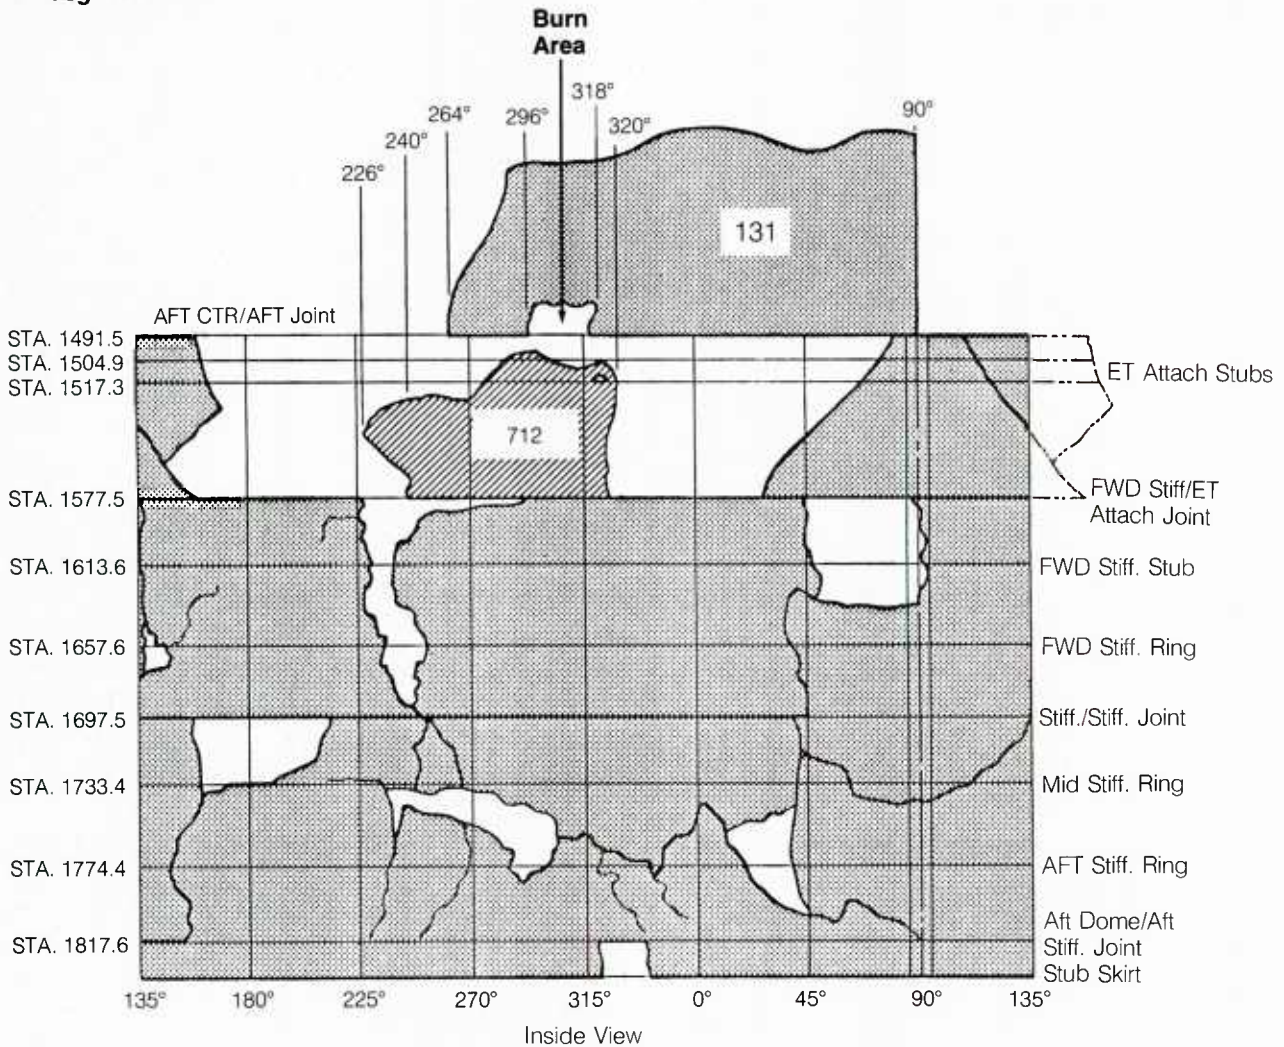
Figure 25  
Drawing depicts pieces of right Solid Rocket Booster aft segment recovered. At top is piece of aft center segment.

strut. This location was within the center of the burned out zone on the right Solid Rocket Booster (photo G). As a matter of interest, the P12 strut is located close to the point on the circumference where the booster case experiences maximum radial deflection due to flight loads. It seems likely that the plume from the hole in the booster would impact near the location of the P12 strut connection and the External Tank. Using geometric considerations alone suggests this strut separated from the External Tank before it separated from the right hand Solid Rocket Booster.

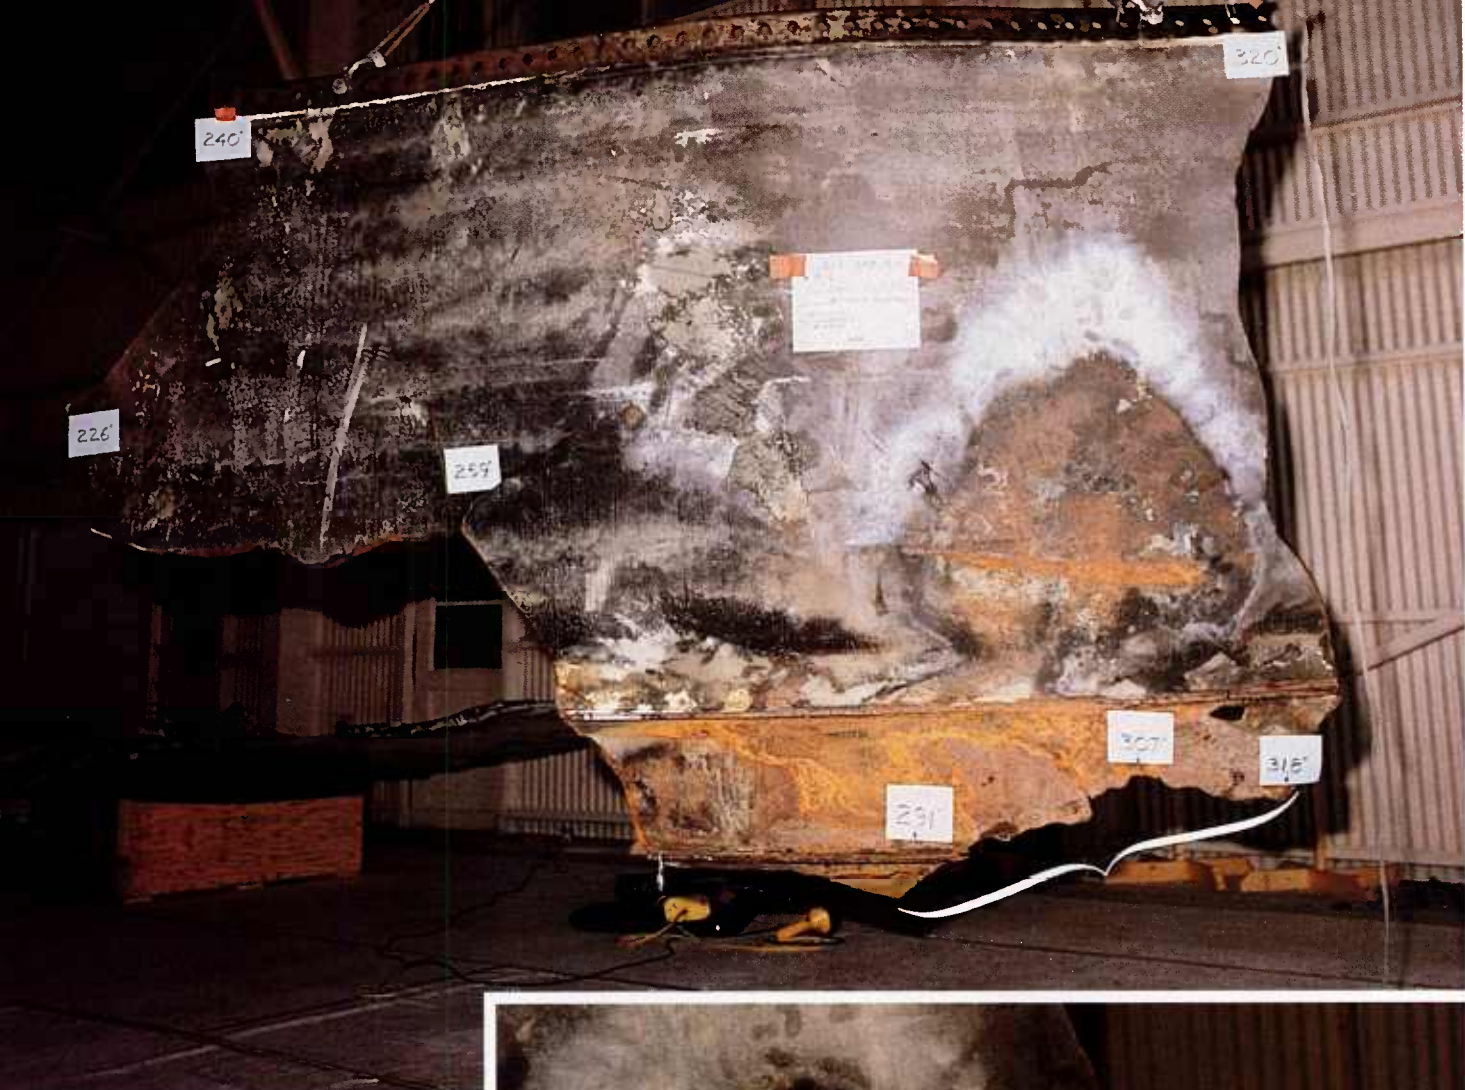
L

Examined at Kennedy Space Center after their recovery from the ocean, these fragments show the extent of burn through the right hand booster's aft field joint. On the left page are sections of the aft center motor segment above the joint. On the right page are sections (inverted) of the aft motor segment showing burn-hole below the joint (bracket). Except for the interior views on lower left, the camera is viewing the parts from outside the casing.

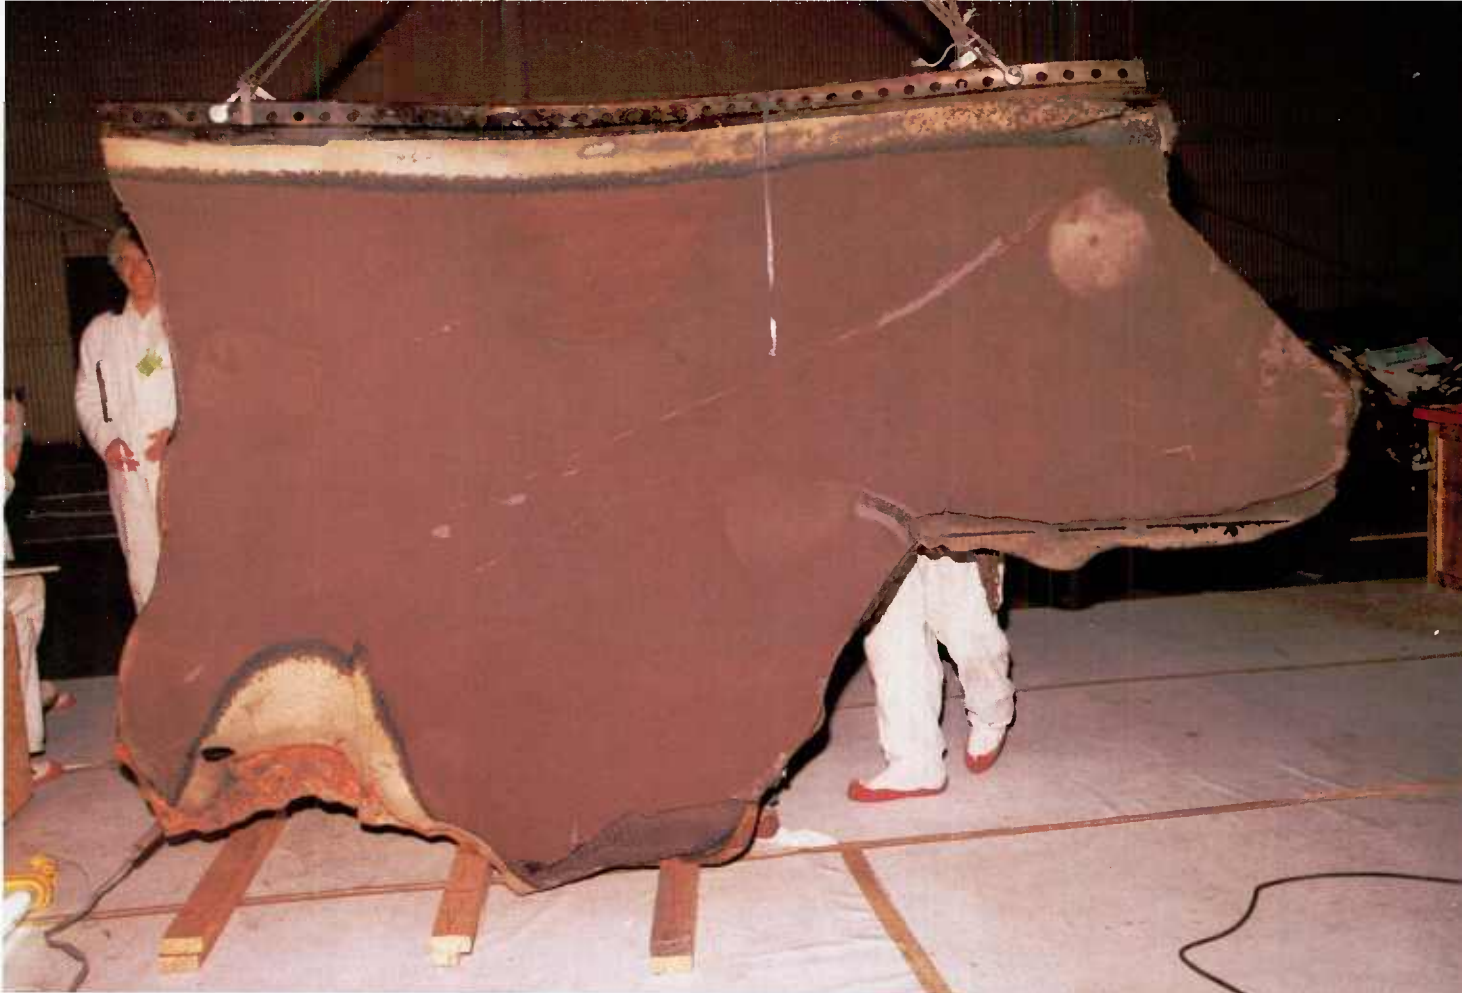
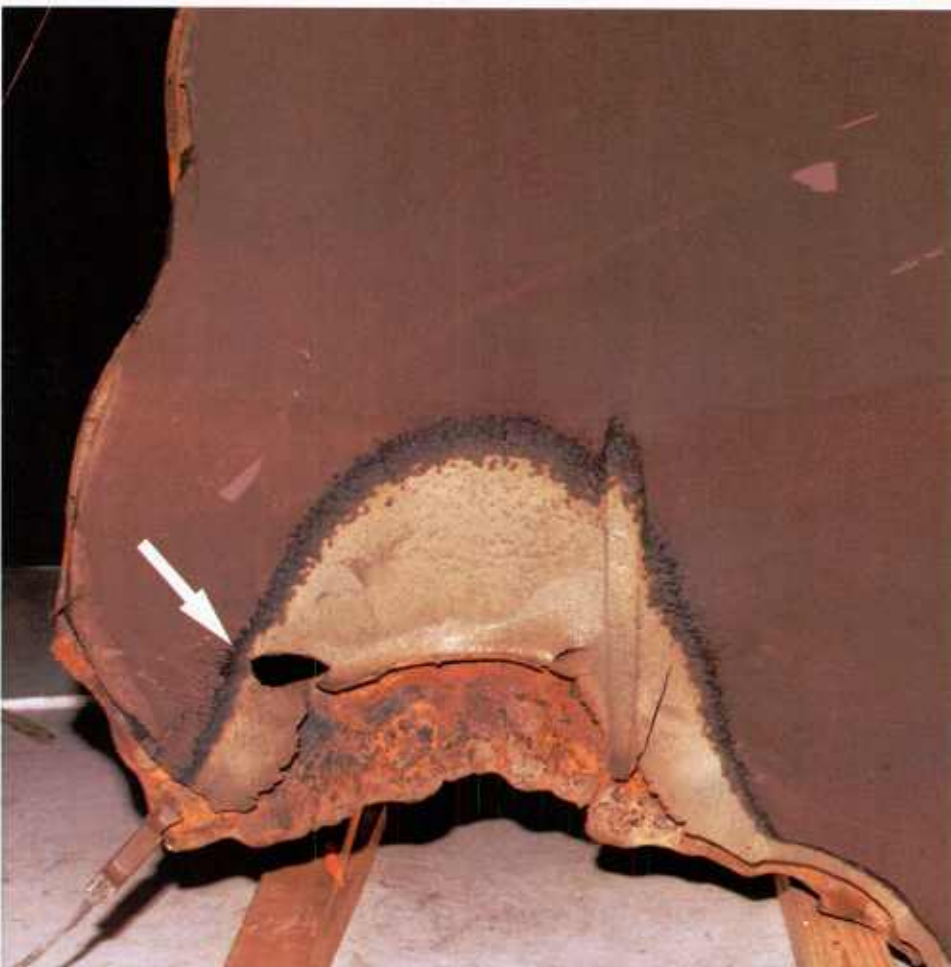
N

At upper left is the aft segment burn viewed from inside the casing; the lower photo is a closeup of the same section. The latter photo shows a hole (arrow) where the flame plume may have burned through the casing from the outside. At right is a composite view of the burn above and below the aft field joint.
